Poor stability caused man overboard

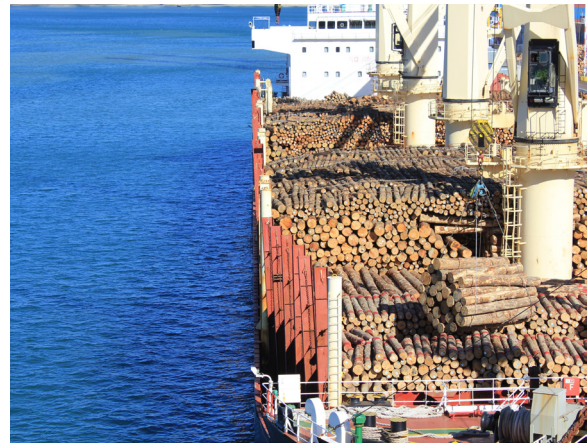
As the vessel was approaching the port, one of the ABs went forward to prepare for arrival. At the same time as the vessel altered course, a heavy gust of wind hit the side of it and caused the vessel to list almost 20° which caused the deck cargo to shift. Because the cargo shifted the vessel started to list almost 40°. This had a spiralling effect and the lashings started to break and logs fell into the sea.

At the same time the AB on the bow fell into the water because of the excessive list. He wasn't wearing a life jacket. The AB could be seen holding on to some logs. The Master on the bridge lost sight of him for a

- In the following investigation it was found that some of the cargo lashings were not strong enough. Some of the straps also had cuts and abrasions which means they were even less strong.
- The vessel was also found to be overloaded.
- The vessel did ballast as per the stability booklet in the loading port, but deballasted too much before arrival. This, in combination with the deck cargo, caused the intact stability criteria to be insufficient. The vessel had almost no stability when approaching the port.
- When the vessel made the last alteration and was hit by the gust of wind, which was only at 6 on the Beaufort scale it caused the vessel to list heavily because of the poor stability.
