TECHNICAL AND REGULATORY NEWS No. 08/2016 – Rules &amp; standards

# ENHANCING FIRE SAFETY AWARENESS

May 2016

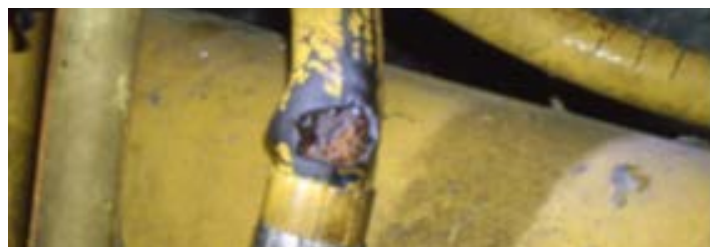
Figure 1: Failed flexible hose which caused an engine fire

Flexible hoses have a limited lifetime under normal conditions, but this lifetime is greatly reduced if the installation is arranged outside acceptable tolerances, for instance when the radius of a bend is less than the minimum required or when the tightening of the connection introduces a twist in the hose. See MSc.1/Circ.1321 for examples of good and bad flexible hose installations.

Since flexible hoses are typically installed in locations with relative movement, care should be taken to prevent scuffing of the hoses. The hoses should preferably not have any contact with other pipes, hoses or machinery parts in order to minimize the risk of scuffing damage.

Because of the limited lifetime of flexible hoses, it is recommended to screen the entire hose and not just the connections.

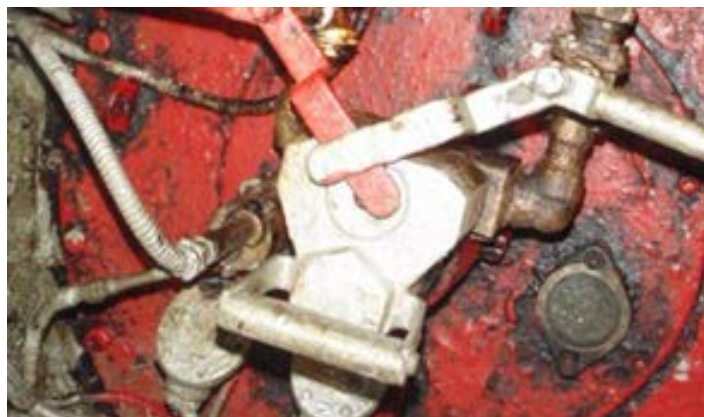
Figure 2: Missing screening of boiler fuel piping connections

MSC.1/Circ.1321 states that spray shields should be applied both for piping systems and for pressurized equipment and/or fittings on oil fuel systems, such as heat exchangers, tube plates and filter or strainer body joints. By extending this stipulation to include other flammable liquids, a higher fire safety level can be obtained. For example, lubrication oil filters located in the vicinity of the turbo charger should be shielded to prevent leakage from the filter reaching the turbo charger. Please note that fuel oil filters fitted on the engine may not be located near rotating parts or hot components.
