Collisions and Groundings

2011

Contents

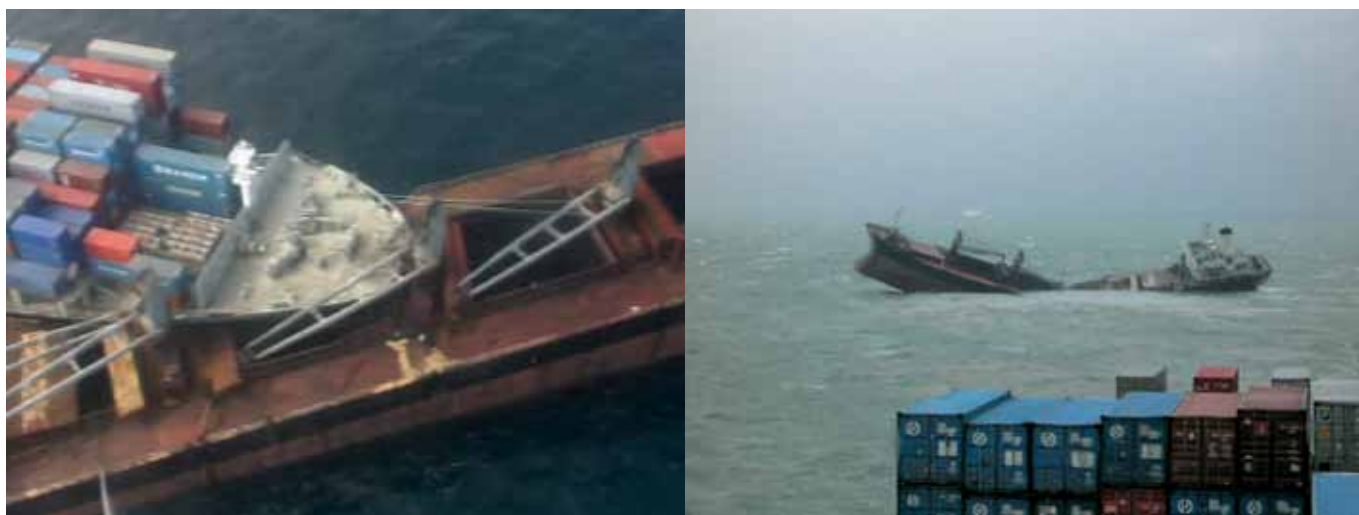
This collision led to the total loss of the bulker. The container vessel had a speed of over 20 knots at the time of the collision.

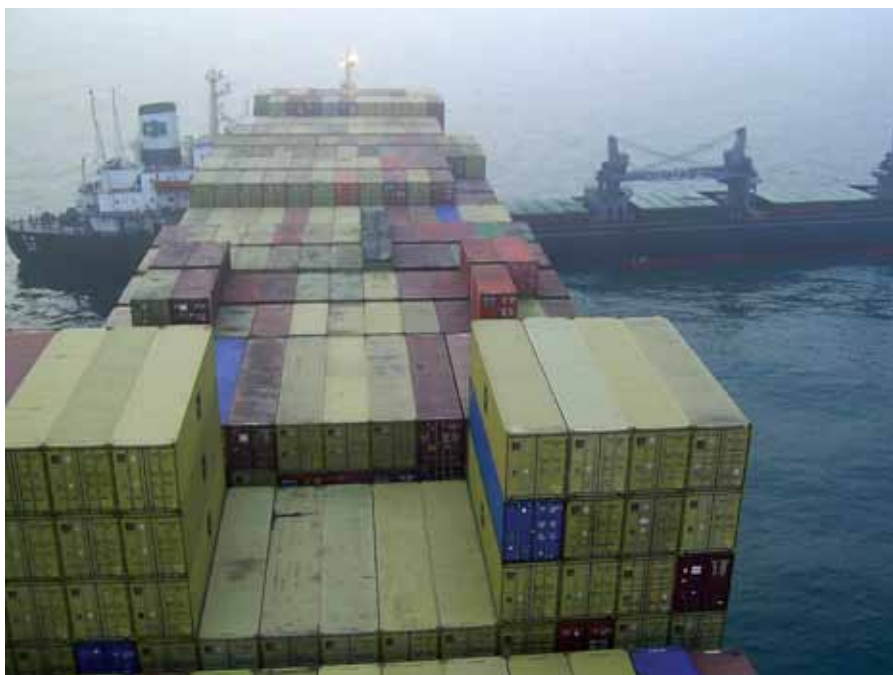
In a couple of cases the captain did visit the bridge when the vessel was in restricted visibility, maintaining full speed and had no designated lookout. Why was no concern raised? How could this be acceptable when it clearly states in the Safety Management System that a designated lookout has to be posted and that the captain should be on the bridge at all times during restricted visibility. In other cases the captain has entered and left the bridge during manoeuvring and obviously did not have full situational awareness. Most

This collision happened in restricted visibility.
