Fire in engine room

It was winter and the vessel, a bulk carrier, arrived at the discharge port to unload a cargo of steel pipes. It had recently undergone a major engine overhaul.

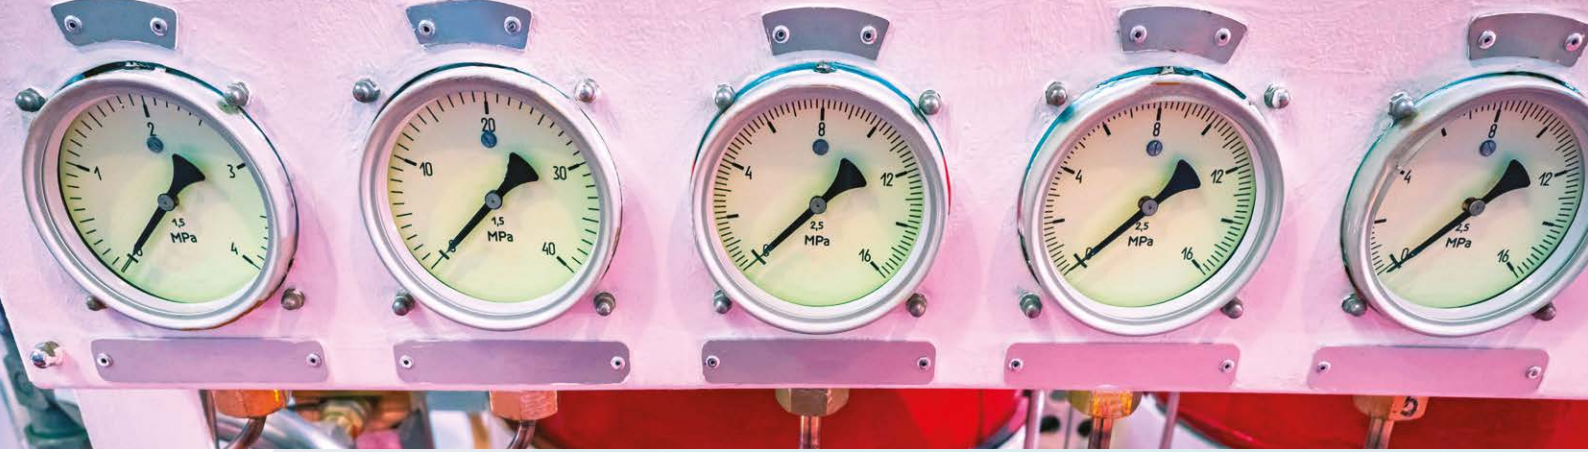
A coast guard vessel arrived the following day and connected towing lines. Another tug also arrived to assist. It was discovered that a fracture had occurred in a small pipe (approximately 4mm diameter) connected to a shut-off valve and gauge/pressure transmitter unit. Fuel then leaked

from the fractured pipe onto the main engine, leading to a fire in the engine room. Ignition was likely due to contact with the hot engine cylinder exhaust manifold.

Repairing the vessel was costly and took three months as all the electrical cabling, insulation, and firefighting equipment in the engine room, in addition to the fuel booster unit, had to be replaced. Cleaning the engine room was a difficult and complicated process.
