Collision at night

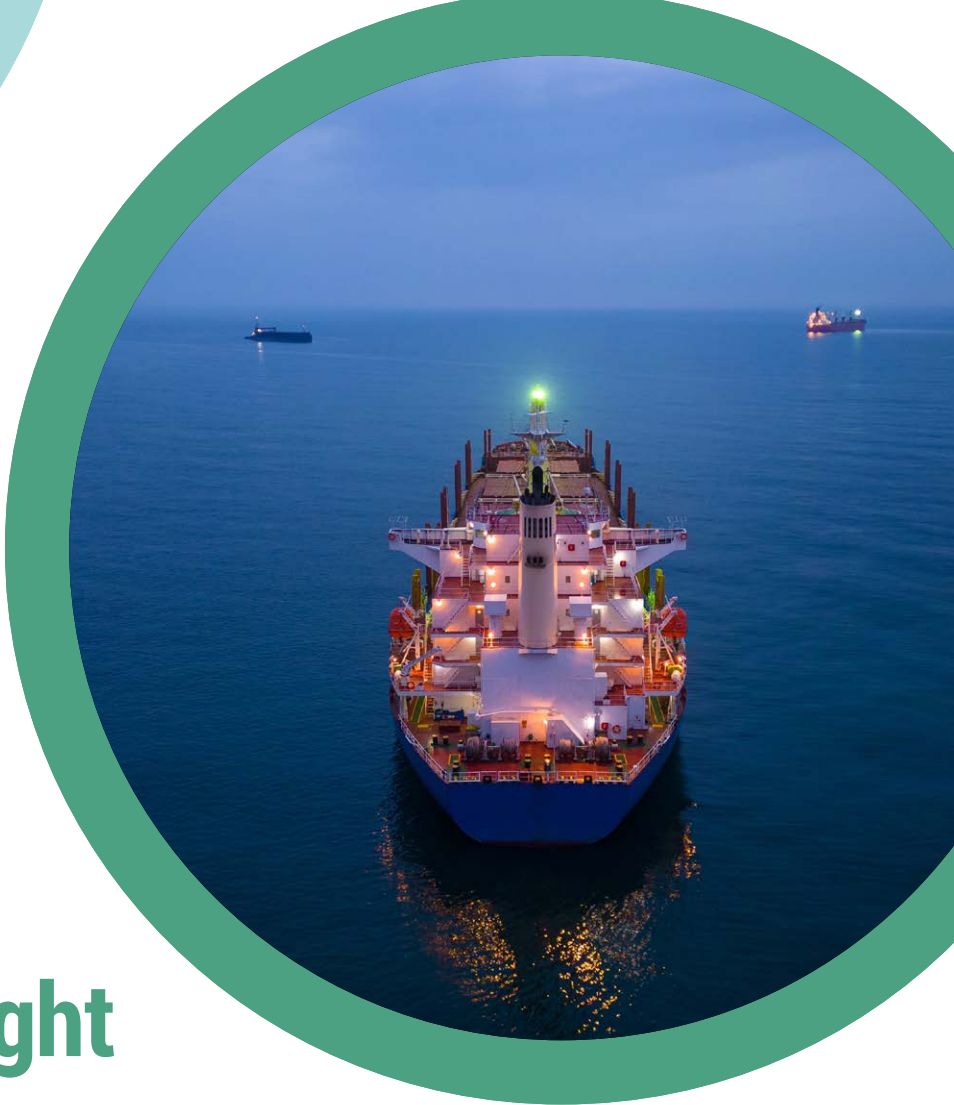
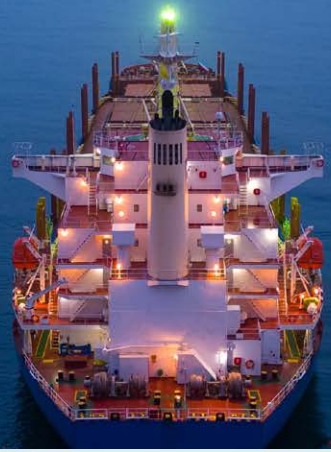
He made these alterations because at the point when he ordered mid-ship, vessel B had crossed the bow from starboard to port by about 30 degrees, and so therefore

felt that vessel B was well clear. Under the circumstances, he was concerned that the stern might be in collision with vessel B if vessel A kept turning to starboard. He further believed that he would be unable to take any further action if he kept altering to starboard.

One minute before the collision the Master of vessel B could see the red light of vessel A on the bow and he ordered full astern.

Unfortunately neither of these actions prevented the collision.
