Collisions and Groundings

2011

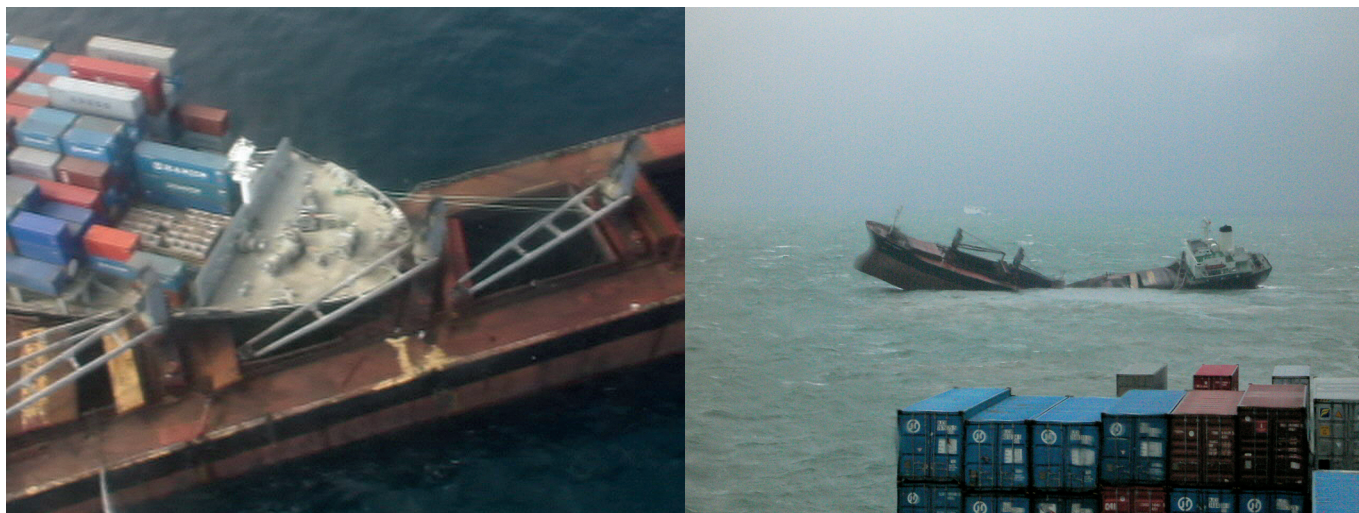
This collision led to the total loss of the bulker. The container vessel had a speed of over 20 knots at the time of the collision.

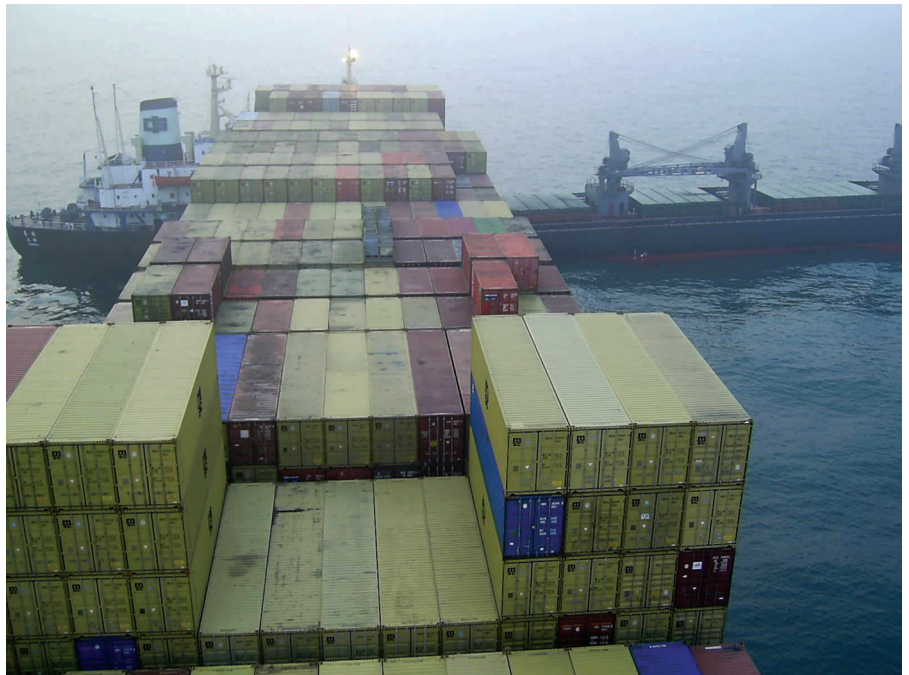
This collision happened in restricted visibility.
