Maintenance job lead to injuries

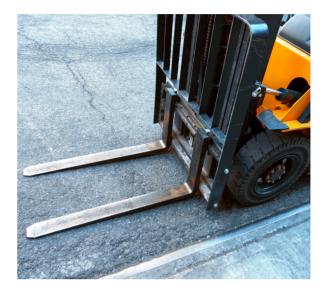
The engineer left for the workshop to get some tools. The two remaining ABs continued to try to find a solution. AB1 started the forklift and rotated the forks with instructions from AB2. The plan was to get the forks in a level position. This was to prevent them from sliding off when the pin had been freed. The engine was switched off after the forks had been rotated and AB1 joined AB2 by the forks. AB1 realised that the good fork was in a position which was preventing easy access to the broken pin, so

they started to release the securing pin for the working fork to pull it out of the way. At this point AB2 held the fork in position with one hand as there were no other securing arrangement. With the other hand he tried to pull the pin out. While he was doing this, he slipped and fell onto the deck. This caused the fork to come lose and hit his hard hat and his hand, it also hit AB1's foot just above the steel cap on his boot. AB1 called for help on the UHF.

When AB2 was moving the fork, it slid past the groove. This caused the fork to come off the carriage. The manual for the forklift was never reviewed and no risk assessment was completed for the job.
