Poor stability caused man overboard

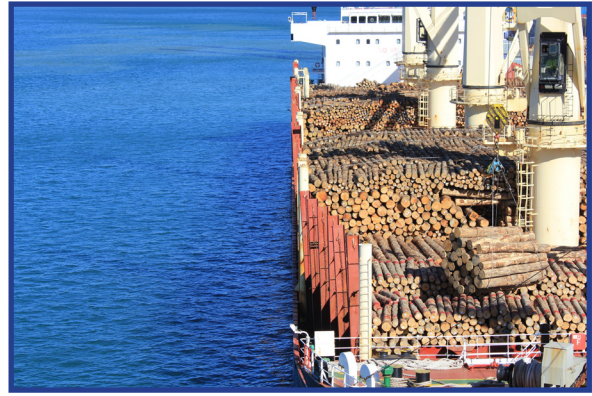
- In the following investigation it was found that some of the cargo lashings were not strong enough. Some of the straps also had cuts and abrasions which means they were even less strong.
- The vessel was also found to be overloaded.
- The vessel did ballast as per the stability booklet in the loading port, but deballasted too much before arrival. This, in combination with the deck cargo, caused the intact stability criteria to be insufficient. The vessel had almost no stability when approaching the port.
- When the vessel made the last alteration and was hit by the gust of wind, which was only at 6 on the Beaufort scale it caused the vessel to list heavily because of the poor stability.
