Fire in engine room

It was winter and the vessel, a bulk carrier, arrived at the discharge port to unload a cargo of steel pipes. It had recently undergone a major engine overhaul.

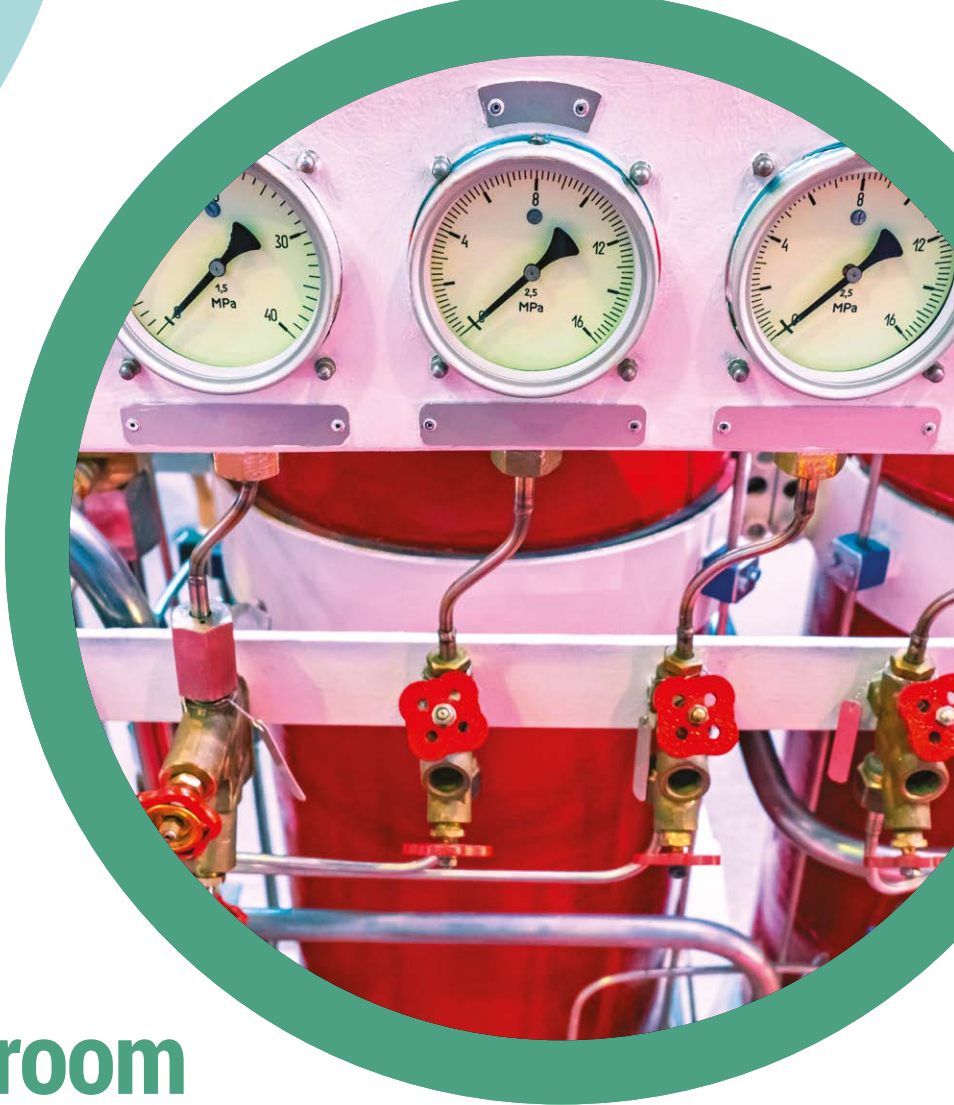
At 05.55 the fire alarm sounded in the engine room. The Second Engineer went to the engine room and saw fire coming from the main engine in the area of cylinders 8 and 9.

stop in the engine control room. The Chief Engineer observed fuel spraying from the fuel booster unit's forward end, and took action to stop the pumps, and close the valves. Attempts to extinguish the fire were unsuccessful. Because of the vessel rolling, fuel which had accumulated on the upper engine room deck spilled onto the top of the main engine and hot exhaust. The fire spread to multiple cylinders, and the crew evacuated the engine room, and the CO2 system was released. However, the system did not work as intended as some of the piping was in bad condition and not all the bottles were released.

A coast guard vessel arrived the following day and connected towing lines. Another tug also arrived to assist. It was discovered that a fracture had occurred in a small pipe (approximately 4mm diameter) connected to a shut-off valve and gauge/pressure transmitter unit. Fuel then leaked

from the fractured pipe onto the main engine, leading to a fire in the engine room. Ignition was likely due to contact with the hot engine cylinder exhaust manifold.

Repairing the vessel was costly and took three months as all the electrical cabling, insulation, and firefighting equipment in the engine room, in addition to the fuel booster unit, had to be replaced. Cleaning the engine room was a difficult and complicated process.
