Cargo shifted during North Atlantic crossing

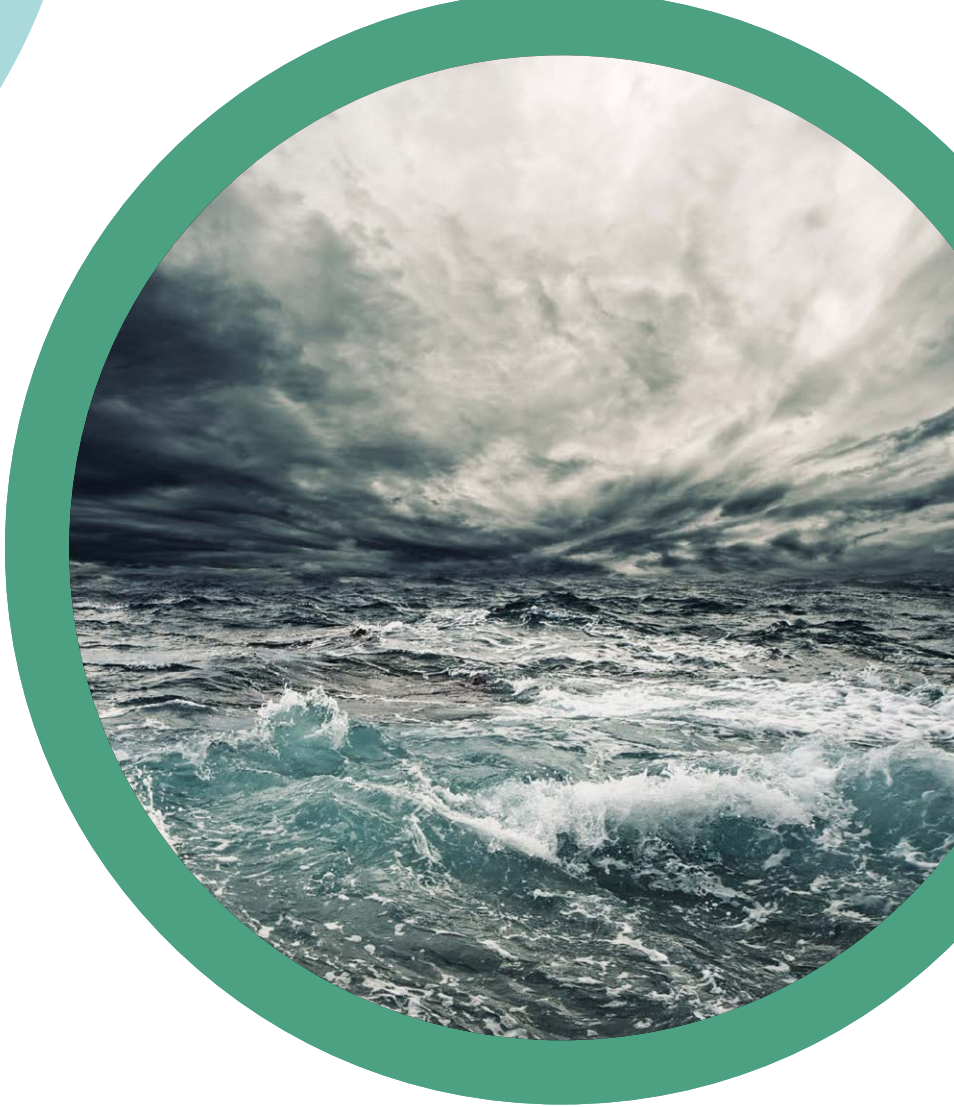
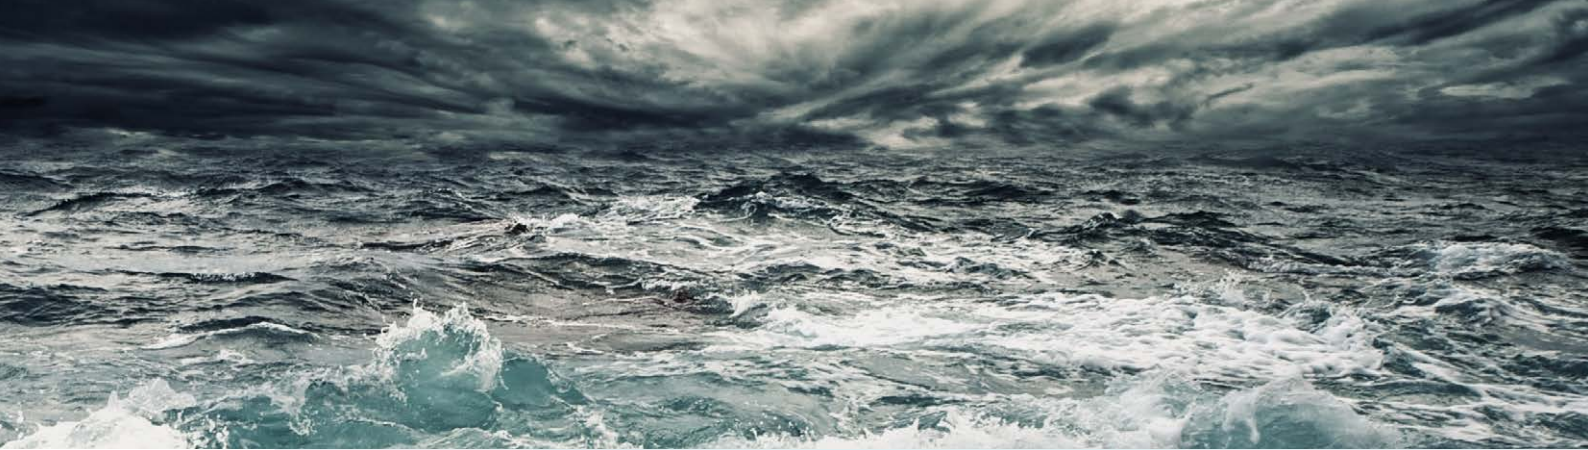
As the vessel encountered force 9-10 winds and 6-meter seas, it began to heel heavily, with rolling exceeding 30°. The shifting cargo created a hazardous situation. The crew's attempts to stabilize the stacks using air cushions and rubber bags were ineffective due to the excessive void spaces, and the risk of serious injury forced them to abandon their efforts. An AB was stationed in the hold to monitor the situation, compounding safety concerns. Eventually, the Master activated the anti-heeling system and adjusted the vessel's stability and speed, but these measures came too late to prevent extensive damage to the cargo.
